Institute of Petroleum Refining and Petrochemistry

BITUMENS AND ROADS

The main types of road surface destruction

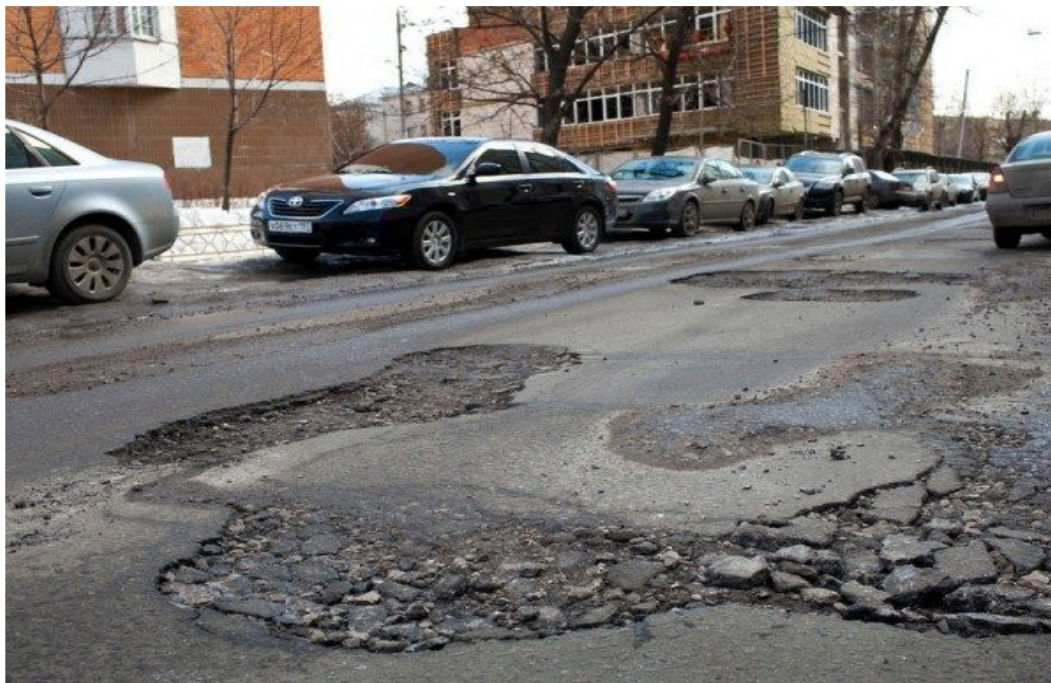
Premature cracking and fatigue fracture of the wearing coat

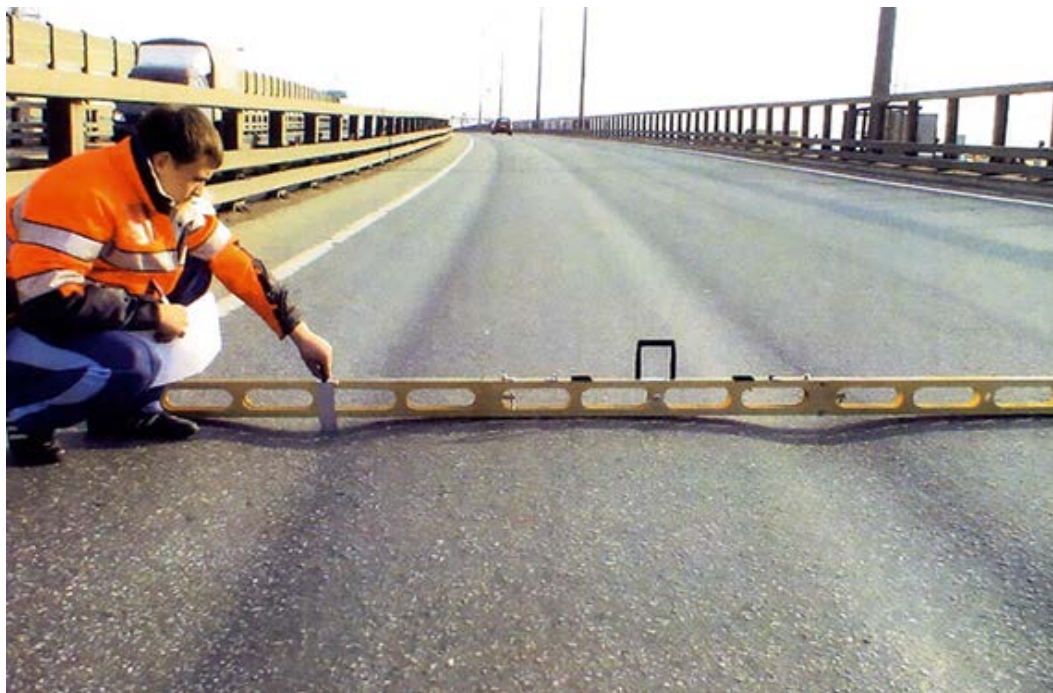
Increased rutting

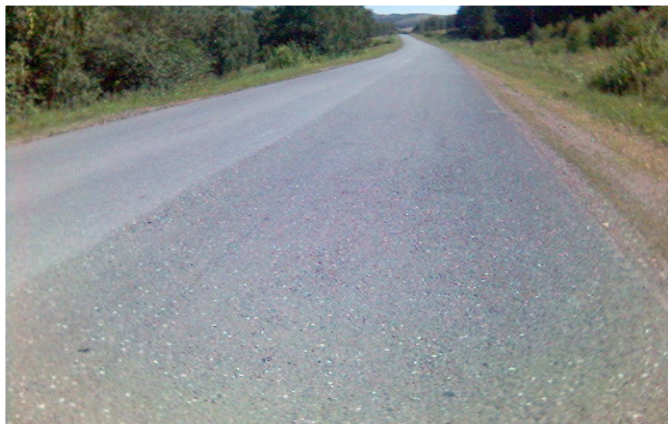
The Beloretsk-Uchaly road. The section (26 -36 km)

The section was built using unoxidized compounded road bitumen under the Technical Conditions of the Republic of Bashkortostan in June 1994.

The picture was taken in July 2012.

It has not been repaired for 18 years.

Potholes, cracks, other visible damages to the pavement are absent.

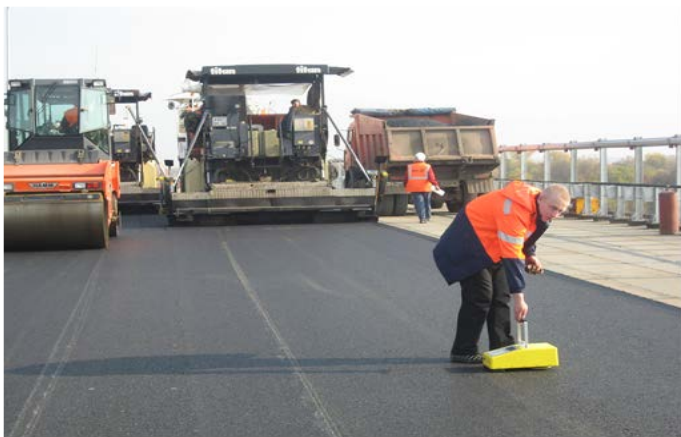
Highway bridge across the Ufa river

The bridge was built in 2008.

It has not been repaired for 10 years.
